APPENDIX E

Tree Survey and Impact Report

**WEST BROADWAY MEDICAL SERVICES BUILDING
TREE SURVEY REPORT**

Date: February 23, 2006

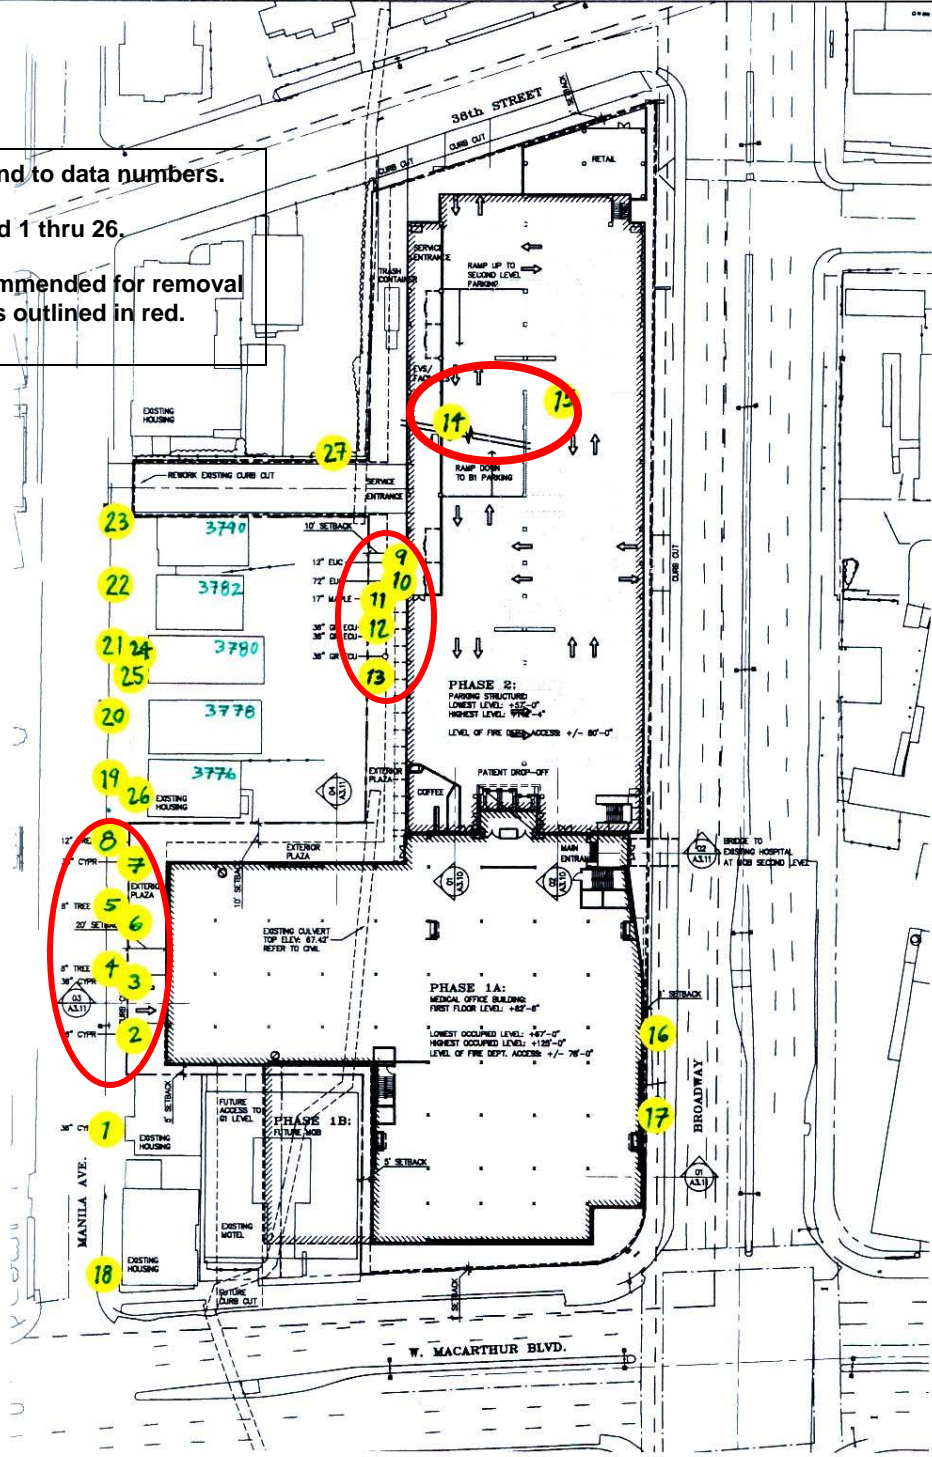
TREE LOCATION MAP

Numbers correspond to data numbers.
Trees are numbered 1 thru 26.
The 14 trees recommended for removal are within the areas outlined in red.

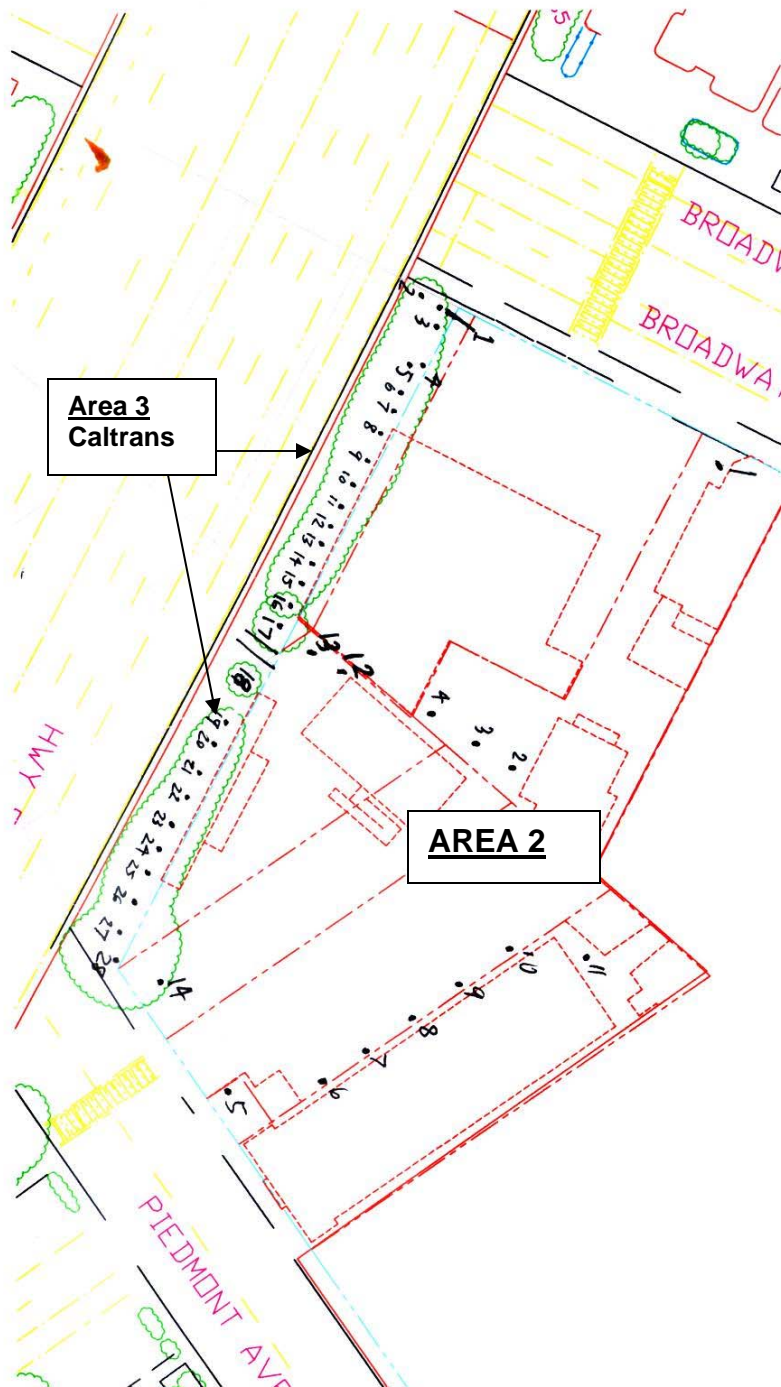
Area 2 and Area 3

The location map below shows locations of trees in area
