INSPECTION 5

PROJECT: LEONA QUARRY TREE PROTECTION

SUBJECT: Monthly Inspection Report

INSPECTION DATE: 6/24/05

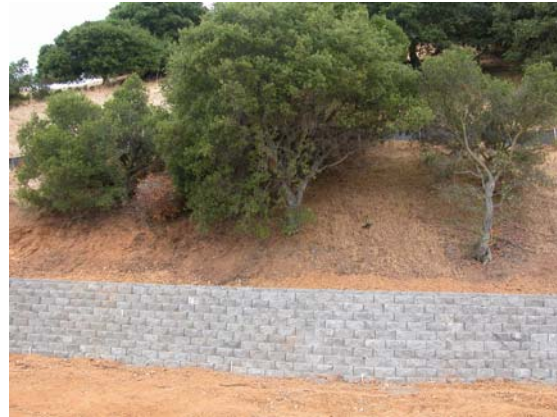
Trees #'s (323, 324, 331, 332, 339) were originally designated for removal. It now appears that the trees will be retained. The adjacent retaining wall is in place and no further grading activity is planned for around the trees. These trees have suffered some root loss from the grading.

Photo 1. Photo shows the Coast Live Oak trees that had earlier been designated for removal. The roots have been exposed by grading. The retaining wall has been completed and no further activity is planned for the area. These require mulch and water.

If the trees are to be retained as it now appears, the trees require mitigation treatment to prevent decline and possible death as a result of the grading. The dead stem also requires removal.

Mulch – Apply mulch over the bare soil and exposed roots. Mulch all possible area that is within 20 feet of the trees. Mulch should be applied to a thickness of 6-8 inches.

Water – All trees will require the application of three inches of water to the soil surface. Application of water should be after the mulch is in place. Water application rate must be slow enough to avoid runoff. This is accomplished by watering a number of times until the necessary water has been applied. The

water trucks can likely spray the area quite efficiently. Soil moisture will be monitored by project arborist. Water application is required only one time during this year. Depending upon tree condition, additional watering may be required during the spring of 2006.

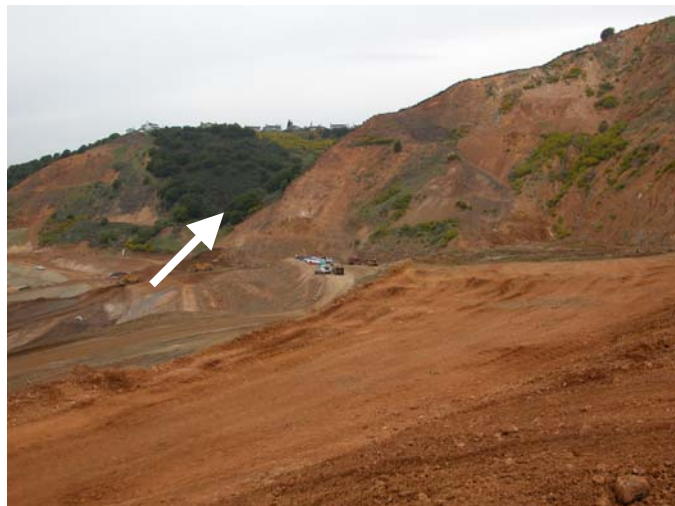
The planned drain line excavation will be in the area of the drainage basin where tree #351 is located. The trenching is to travel up the slope. The final location of the trench and width of the work area have not yet been determined.

Photo 2. Arrow indicates the location where the trenching will begin and the direction of the proposed drain line trenching.

It will be most efficient if the project arborist is present at the time the initial alignment plan is designated.
