Date: July 19, 2005

INSPECTION 6

PROJECT: LEONA QUARRY TREE PROTECTION
SUBJECT: Monthly Inspection Report
INSPECTION DATE 7/13/05

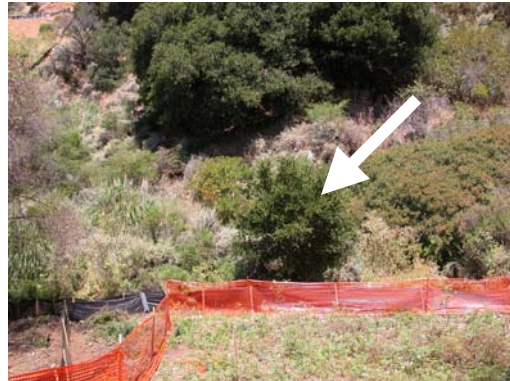
This previously untagged and un-surveyed Coast Live Oak (*Quercus agrifolia*) is growing near the back of the basin area. The tree is not large but the current size qualifies it as a protected tree. It is likely that the original survey did not include this tree because it was below minimum size at the time.

The live oak tree has three stems that measure 6", 5" and 4" at 54 inches above average soil grade (DBH)¹. This is equivalent to a single stem tree with a DBH of 9 inches.

It is unsure as to what activity is to take place in the area. At the time of my visit, the tree is protected by orange fencing and silt fencing. The orange fencing is at the required distance (9 feet) from the tree.

Photo 1. The white arrow indicates the location of the subject Coast Live Oak. This tree is safe for now but may require attention later if there is construction activity in the area.

Recommendation – Contact arborist prior to encroachment inside of the orange tree protection fencing.

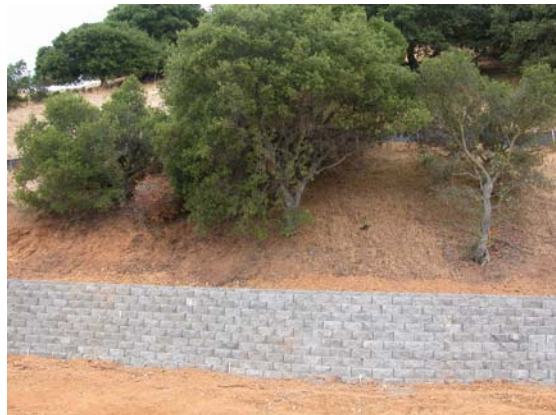
Health mitigation treatments were recommended for these trees in the June 24 inspection report. The mitigation treatment recommended was mulching and watering. To aid in the treatment, additional comments are provided.

Photo 2. Photo shows the cut slope below the oak trees where mulch and water are still required.

Oak Tree Health Mitigation – It is recommended that the treatment be provided as soon as is possible to gain more benefit. The 6-8 inches of mulch can be blown on the surface. One company that provides this service is Jet Mulch. The number I have for Jet Mulch, Inc. is 925-676-7068.

Water application should be accomplished asap but preferably after mulching. The amount of water needed is determined by first measuring the soil surface area to be treated (same as mulched area). Calculate the amount of water needed to provide three inches of water over the entire surface area. If need be, the cubic feet of water requirement can be converted to gallons. Water should be applied slow enough to avoid runoff. One of the water trucks currently on site should be able to accomplish the watering.
