INSPECTION 7

PROJECT: LEONA QUARRY TREE PROTECTION
SUBJECT: Monthly Inspection Report
INSPECTION DATE 8/24/05

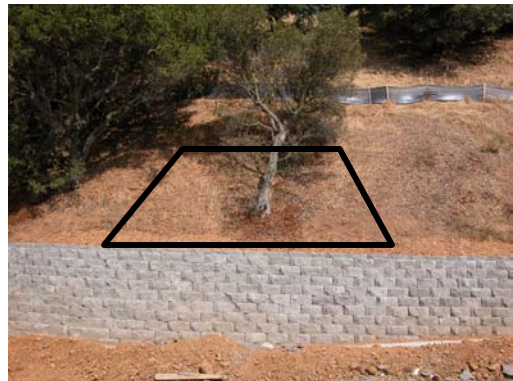
Photo 1. Photo to the right shows the minimal amount of redwood fir bark mulch that was applied under the oak tree. The July 19, 2005 inspection report designated that 6-8 inches of mulch be placed under the tree.

For this tree, the area inside the black line is the area that should have been mulched with 6-8 inches. The area of mulch application is greater for the other trees that are larger in size.

Recommendations – As noted in the 7/13 inspection report, the mulching should have been accomplished immediately to have the maximum benefit. The lack of mulching and watering during the last month has resulted in trees with substantially lower energy reserves. This may contribute to future pest problems. It is recommended that the mulching be completed as soon as is possible.

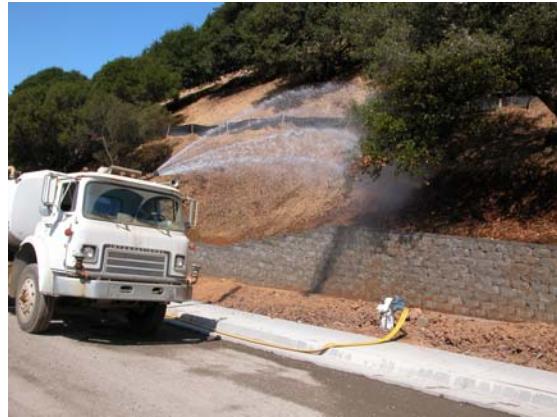
Photo 2. Photo to the right shows the water truck watering the trees on Wed. August 24. The truck was instructed to make successive passes until the designated amount of water had been applied to avoid runoff.
