## INSPECTION 8

PROJECT: LEONA QUARRY TREE PROTECTION  
SUBJECT: Monthly Inspection Report  
INSPECTION DATE 9/27/05

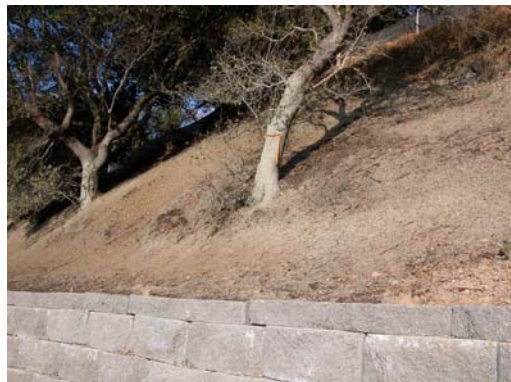
Eighth St. Trees – The five Coast Live Oak trees have now been mulched with compost. Over the compost a layer of hydro-mulch was put in place to hold the mulch and soil in place during winter rains. All needed work in this area has now been completed.

*Photo to the right shows the trees on Eighth St. that have been mulched. Compost was first placed under the trees. The area was then hydro-mulched to hold soil and compost in place.*
