INSPECTION 8

PROJECT: LEONA QUARRY TREE PROTECTION
SUBJECT: Monthly Inspection Report
INSPECTION DATE 9/27/05

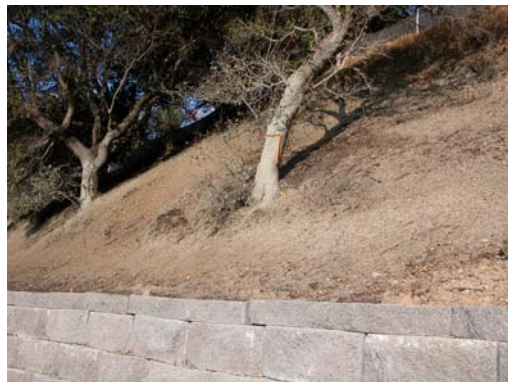
Eighth St. Trees – The five Coast Live Oak trees have now been mulched with compost. Over the compost a layer of hydro-mulch was put in place to hold the mulch and soil in place during winter rains. All needed work in this area has now been completed.

Photo to the right shows the trees on Eighth St. that have been mulched. Compost was first placed under the trees. The area was then hydro-mulched to hold soil and compost in place.
