## **Tree Shading Impact Report on Mosswood Park**

**KAISER OAKLAND MEDICAL CENTER (OMC)**

**MOSSWOOD PARK SHADING**

**TREE SHADING IMPACT REPORT**

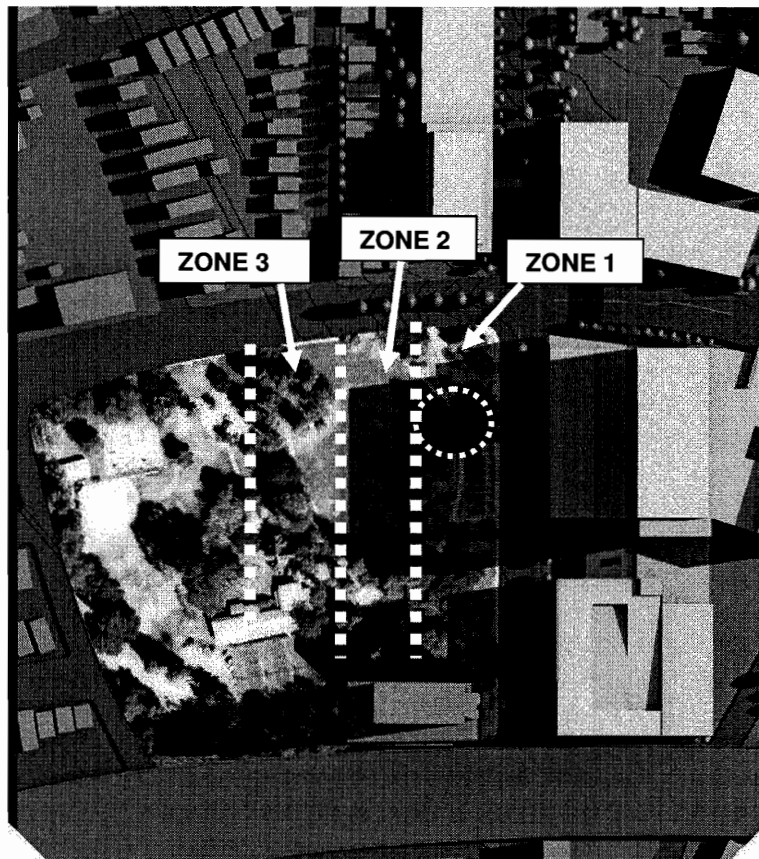
## Zone Location Map

*The graphic diagram below shows the areas where the three zones are located. The area circled is the area where the Chlorophyll Fluorometer was used to sample leaf tissue. The zones are based upon the distance from Broadway. They are respectively 100, 200 and 350 feet from the eastern boarder of the park.*

*Shadow generated from the new structures is on September 21 at 9 A.M..*
